**RENTAL ASSISTANCE DEMONSTRATION
PHYSICAL CONDITION ASSESSMENT (RPCA)
TOWNHOMES AT CARVER PARK
1901 NORTH 6TH STREET
MILWAUKEE, WISCONSIN 53212**

**D3G PROJECT NUMBER:
2021-1730**

**FINAL REPORT ISSUE DATE:
OCTOBER 4, 2021**

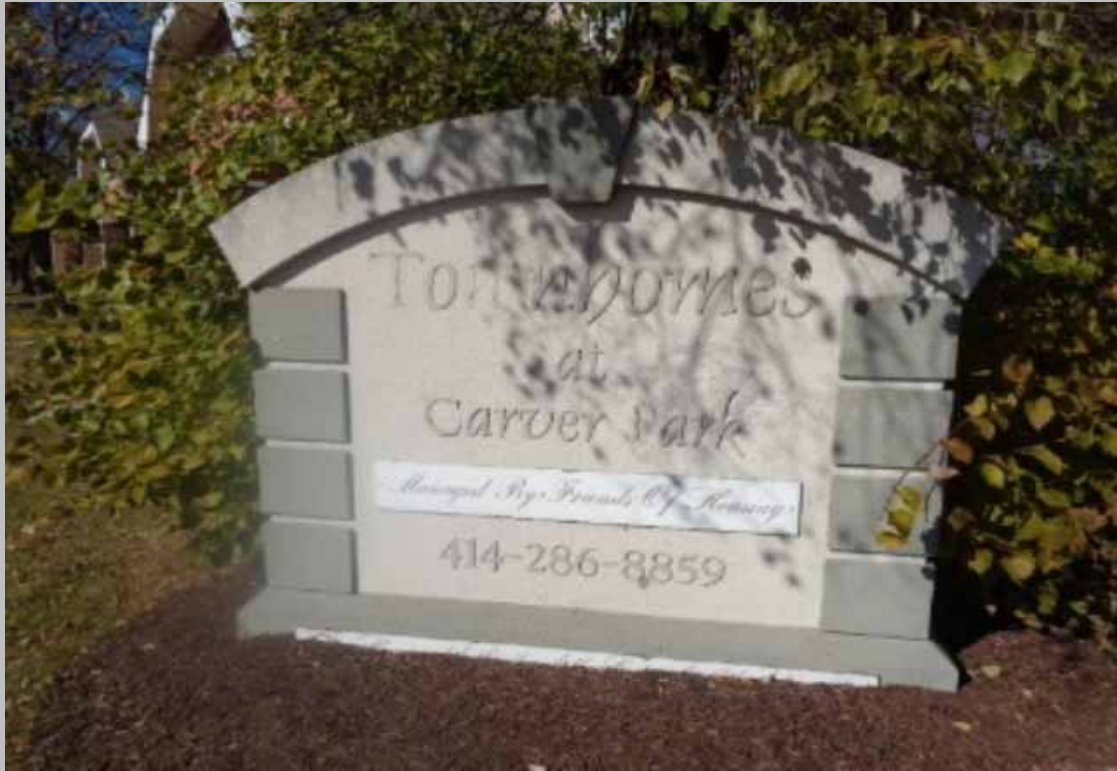
PHOTO #1

Property signs identifying the subject property as “Townhomes at Carver Park” is situated near the driveway entrance to the site. The signs were observed in fair physical condition and nearing their EUL (Non-Critical Repair).

Property signage

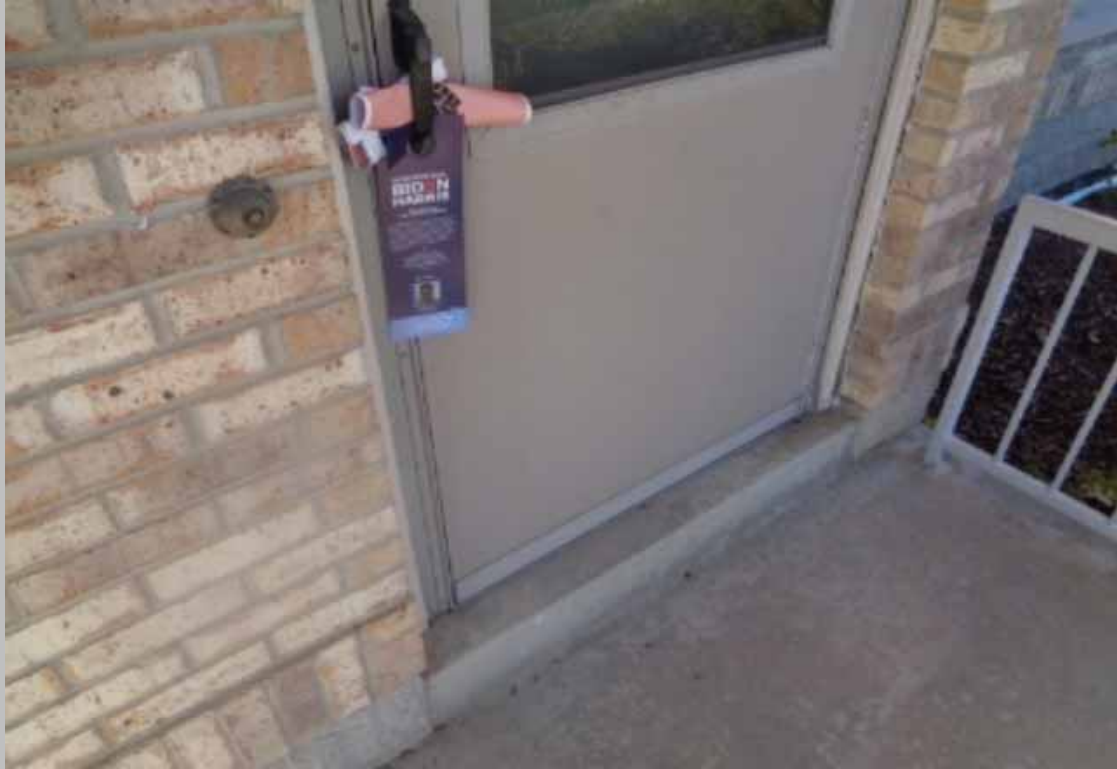
PHOTO #17

Exterior doors at the property consist of single hollow core residential steel assemblies at the front and rear unit entrances. The doors were observed in fair to poor physical condition with replacement recommended as a Non-Critical Repair.

View of typical dwelling unit entry porch and door.

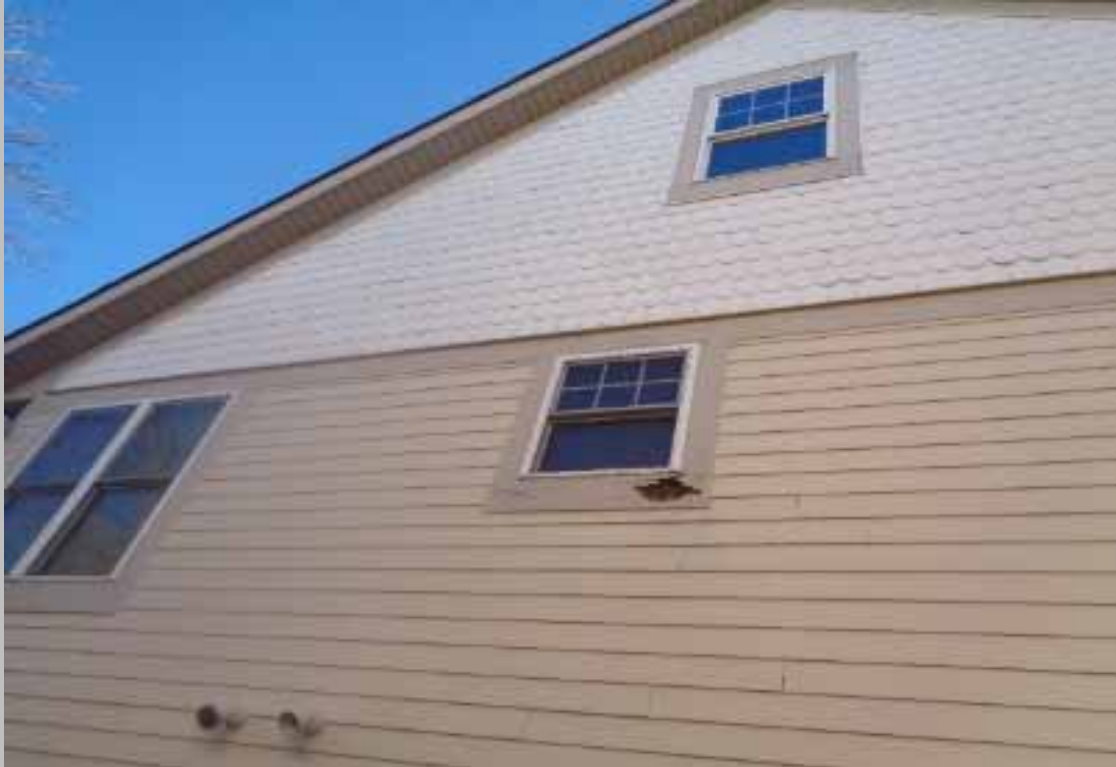
PHOTO #41

View of deteriorated exterior paint and trim observed at buildings throughout the site (Non-Critical Repair).

The exterior wall assemblies consist of conventional 2" x 4" stud framing surfaced with structural wood sheathing and surfaced with a combination of brick veneer, vinyl, and fiber cement lap siding. The exterior walls were observed in fair to poor physical condition. The apartment buildings feature aluminum wrapped wood fascia and aluminum soffit panels that appeared in fair physical condition to poor. Additionally, many areas of exterior trim were observed with damage, wood rot and worn paint. Replacement of the cement and vinyl siding, in addition to carpentry repairs and exterior painting has been included in the Non-Critical Repairs.

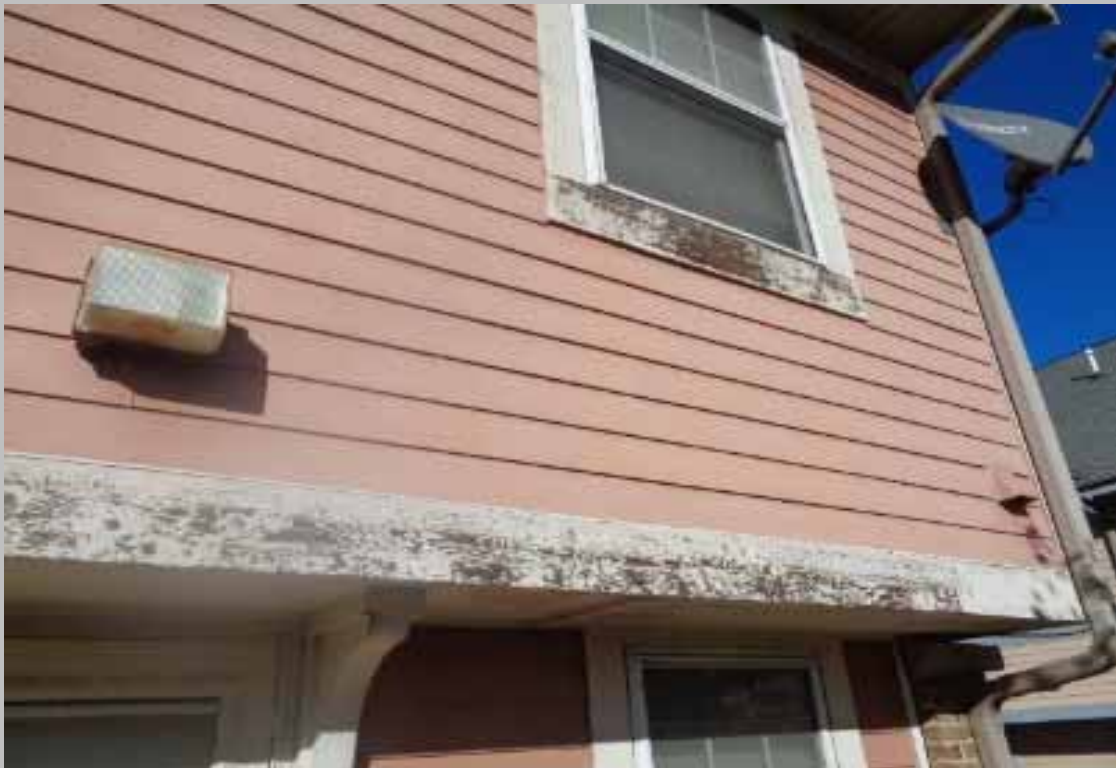
PHOTO #42

View of deteriorated exterior paint and trim observed at buildings throughout the site (Non-Critical Repair).

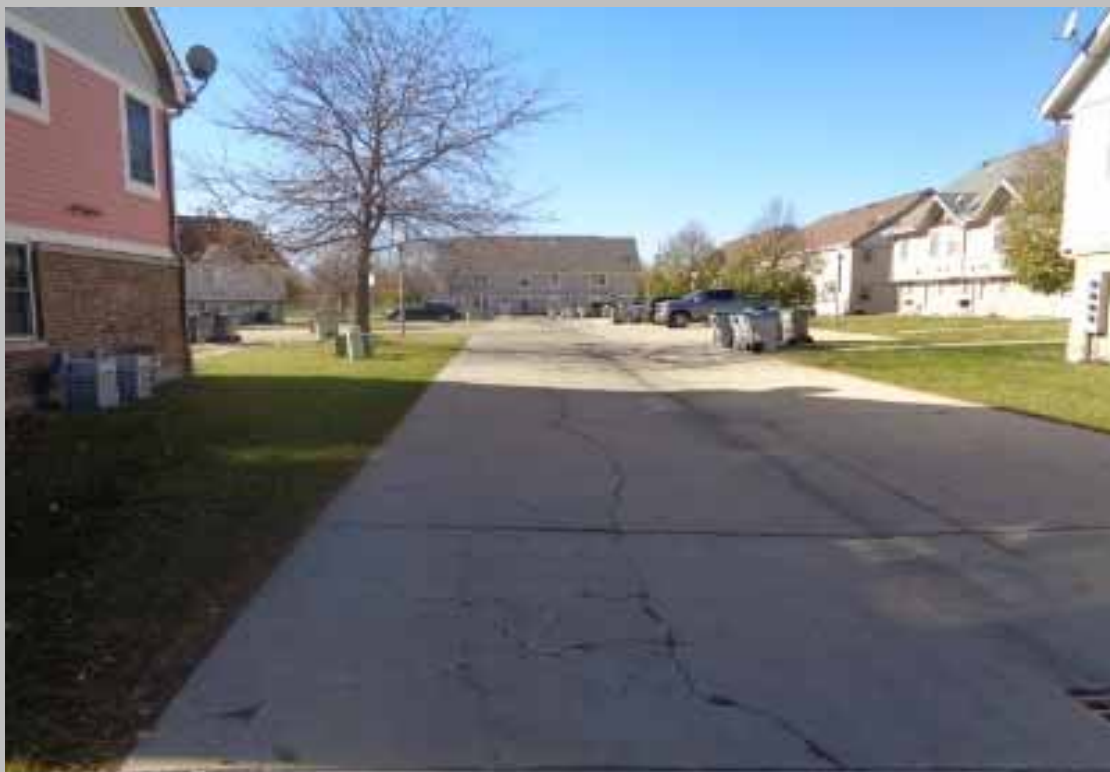
PHOTO #43

View of deteriorated concrete.
(Non-Critical Repair).

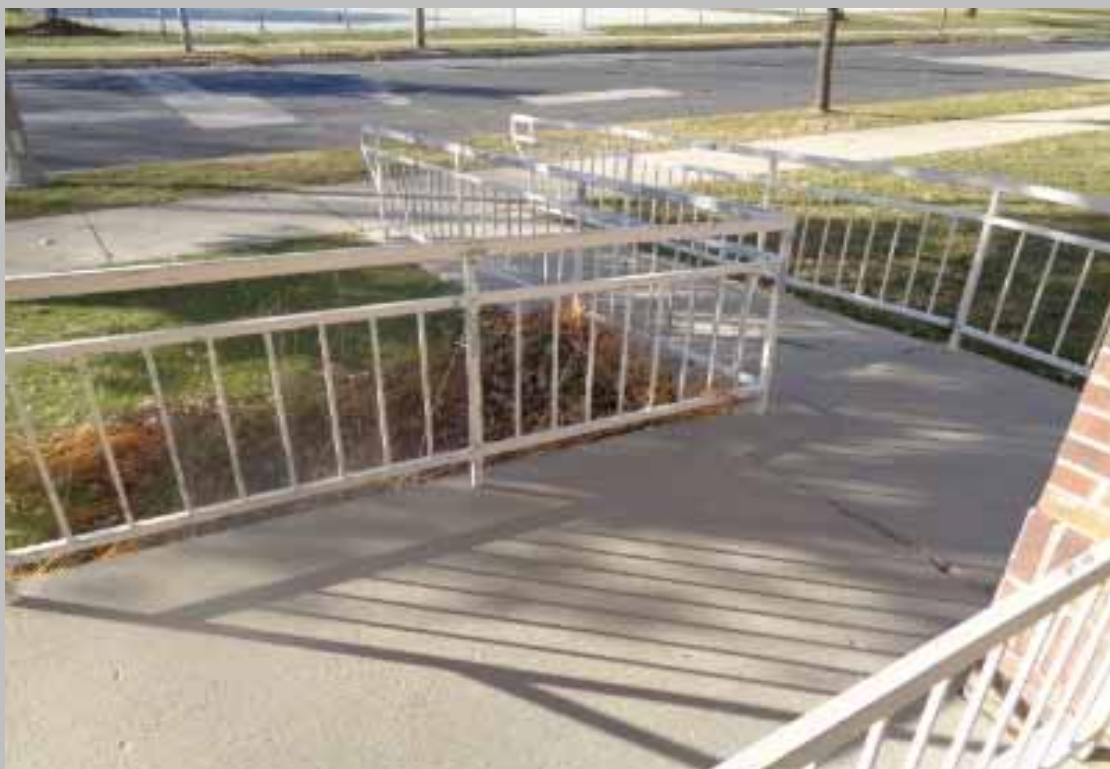
PHOTO #44

View of typical handicapped access ramp at ground floor units, with deteriorated concrete and oversized expansion gaps (Non-Critical Repair).

The site features concrete sidewalks, which are approximately 36-inches wide, and were observed in generally fair physical condition. Concrete handicapped ramps are featured at the designated handicapped units. The concrete ramps were observed in fair to poor condition with repairs included within the Non-Critical Repairs section of this report.

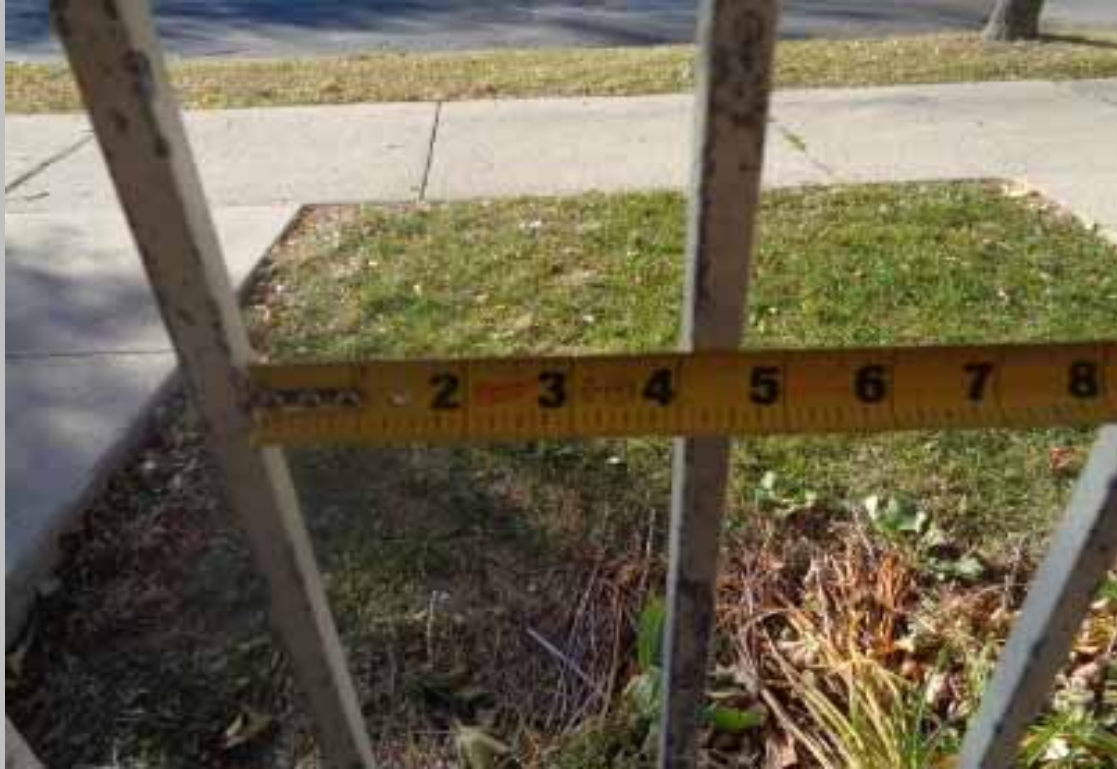
PHOTO #45

View of non-compliant (greater than 4-inches) metal railing balusters (Critical Repair).

Each dwelling unit features a balcony or patio and rear concrete patios or stoop entries. The patios are constructed of reinforced concrete slab on grade assemblies. The balconies are constructed of conventional framing with concrete decking and metal railings. The balconies and patios were observed in fair physical condition. The metal railing balusters were observed with openings greater than 4-inches with replacement included within the Critical Repairs.

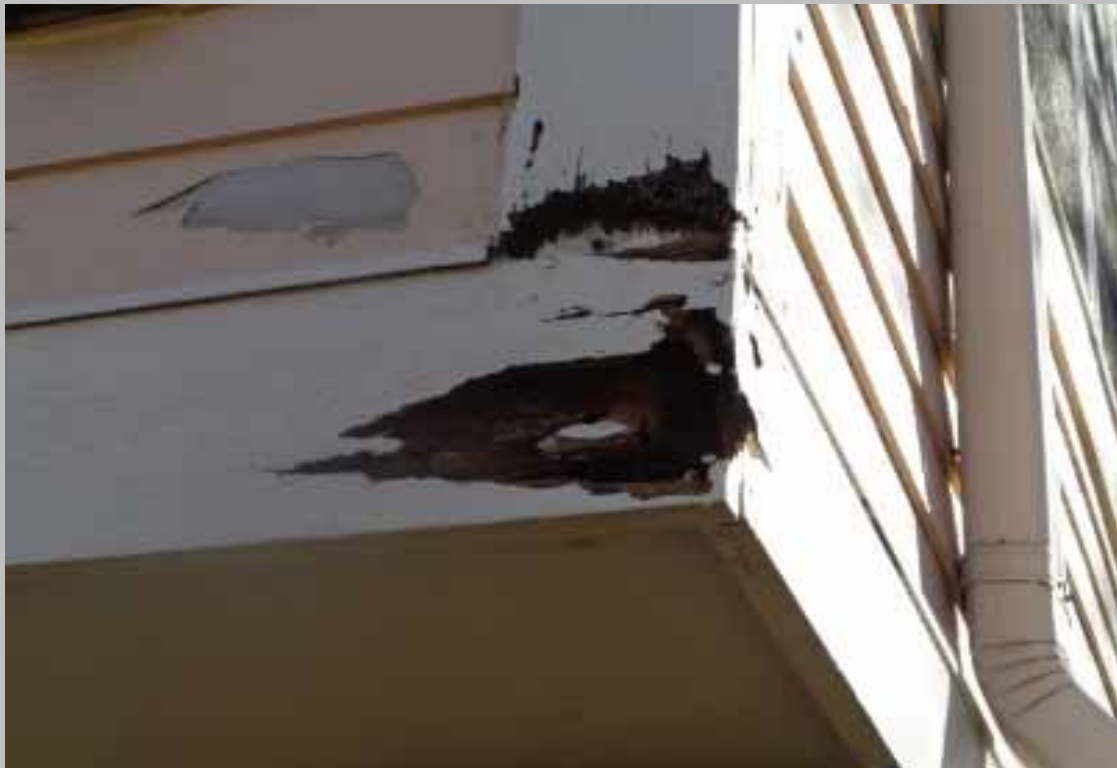
PHOTO #46

View of exterior trim with rot (Non-Critical Repair).

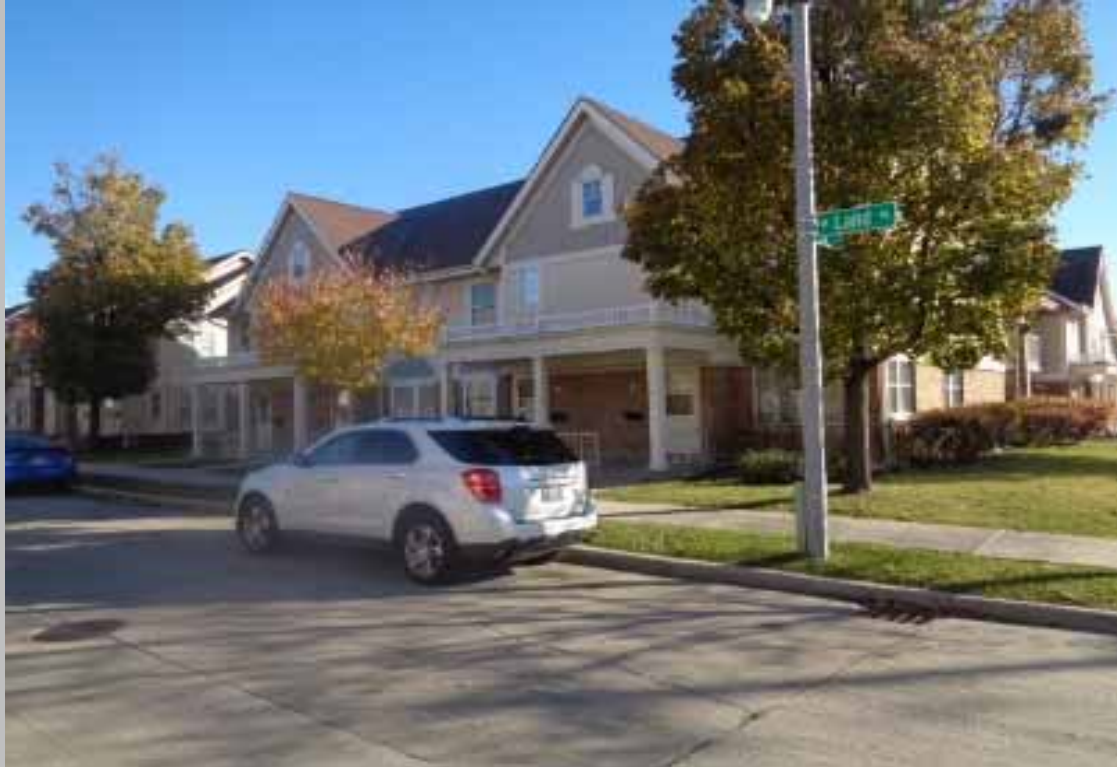
PHOTO #47

View of trees encroaching on the building envelope at select buildings across the site (Non-Critical Repair).

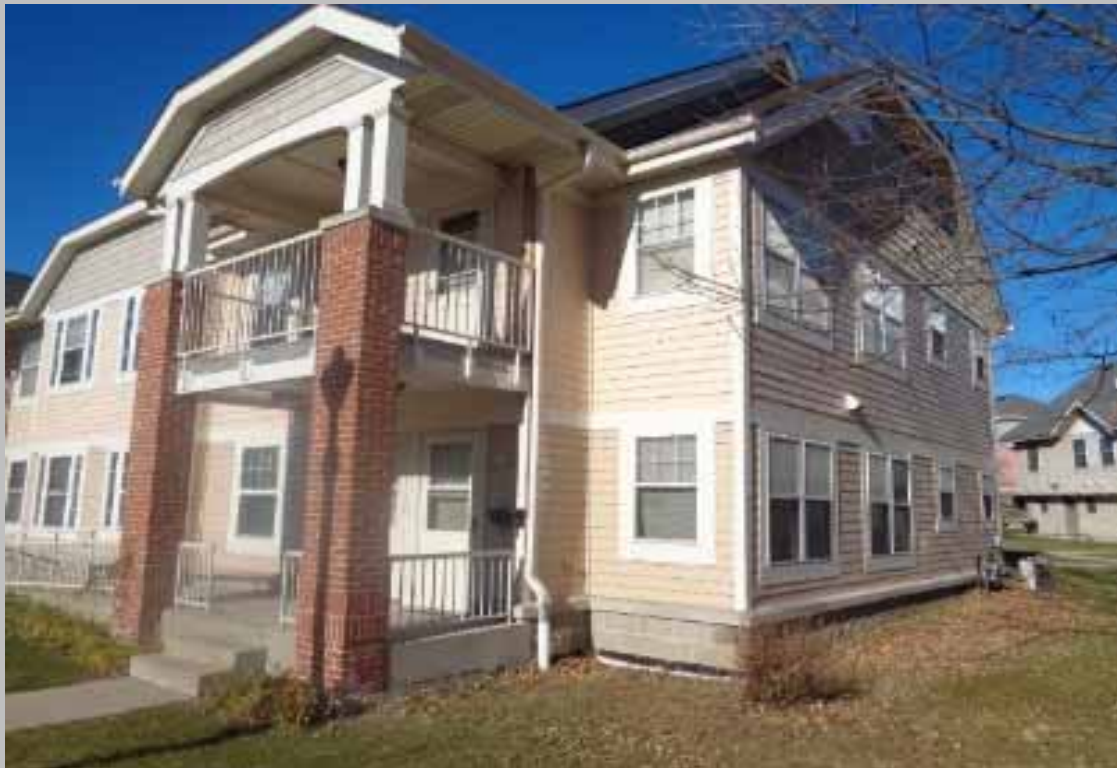
PHOTO #48

Additional view of trees encroaching on the building envelope at select buildings across the site (Non-Critical Repair).
