**PROPERTY CONDITION REPORT
HIGHLAND GARDENS
1818 WEST JUNEAU AVENUE
MILWAUKEE, WI 53233**

**D3G PROJECT NUMBER:
2022-002134**

**REPORT ISSUE DATE:
JANUARY 26, 2023**

**INSPECTION DATE:
DECEMBER 28, 2022**

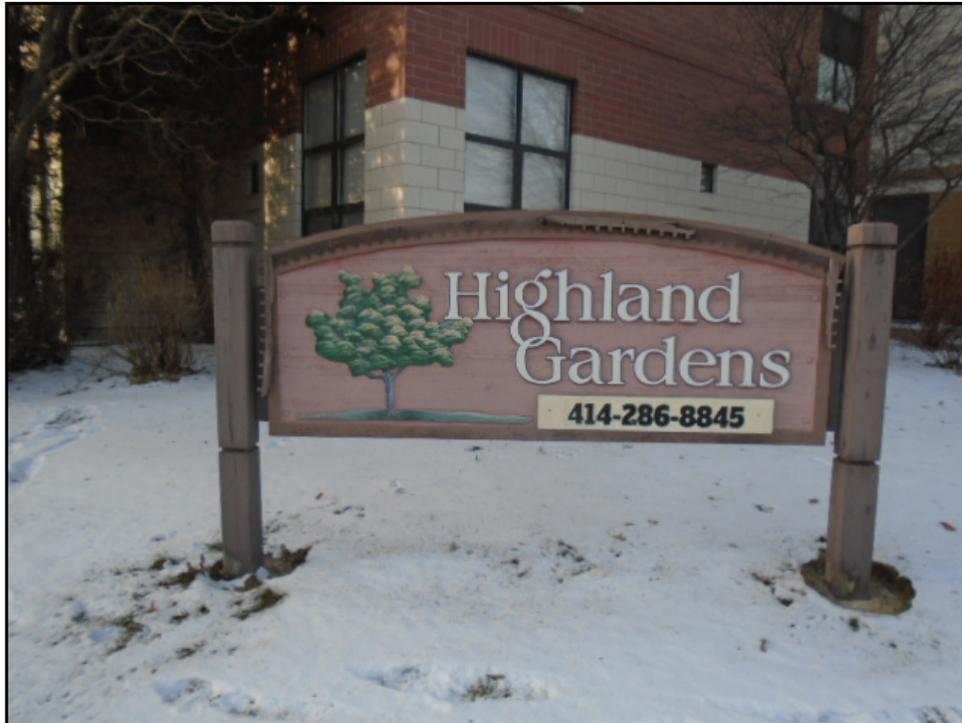
1 : Property Identification Sign

A sign identifying the subject property as Highland Gardens is situated adjacent to the main entrance to the site. The sign was observed in poor physical condition and its replacement has been include within the Immediate Repairs.

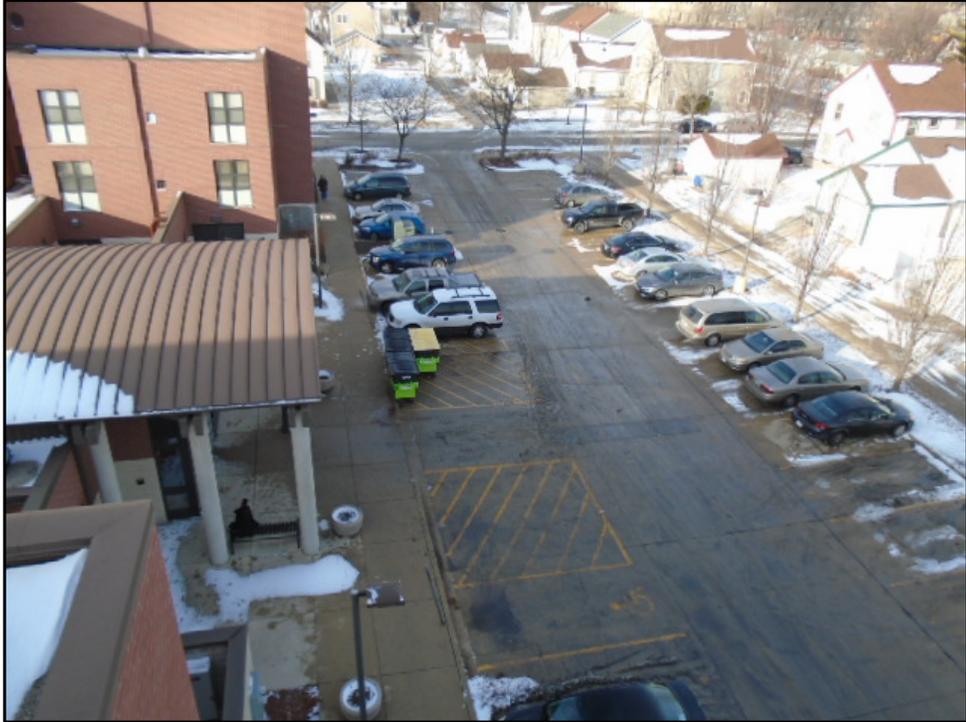
7 : Concrete Parking Lot

The property features two (2) points of vehicular ingress and egress, consisting of concrete driveways on the north side of the property that leads to concrete parking areas. The property provides sufficient parking spaces for residents and guests with parking space configuration designed for continuous traffic flow and convenient access to dwelling units. The drive lanes and parking areas were observed in poor physical condition and their refurbishment has been included within the Immediate Repairs. The property also features a mixture of concrete and brick sidewalks and patios at select locations throughout the site. The sidewalk and patio surfaces were observed in fair physical condition; however, their refurbishment has also been included within the Immediate Repairs

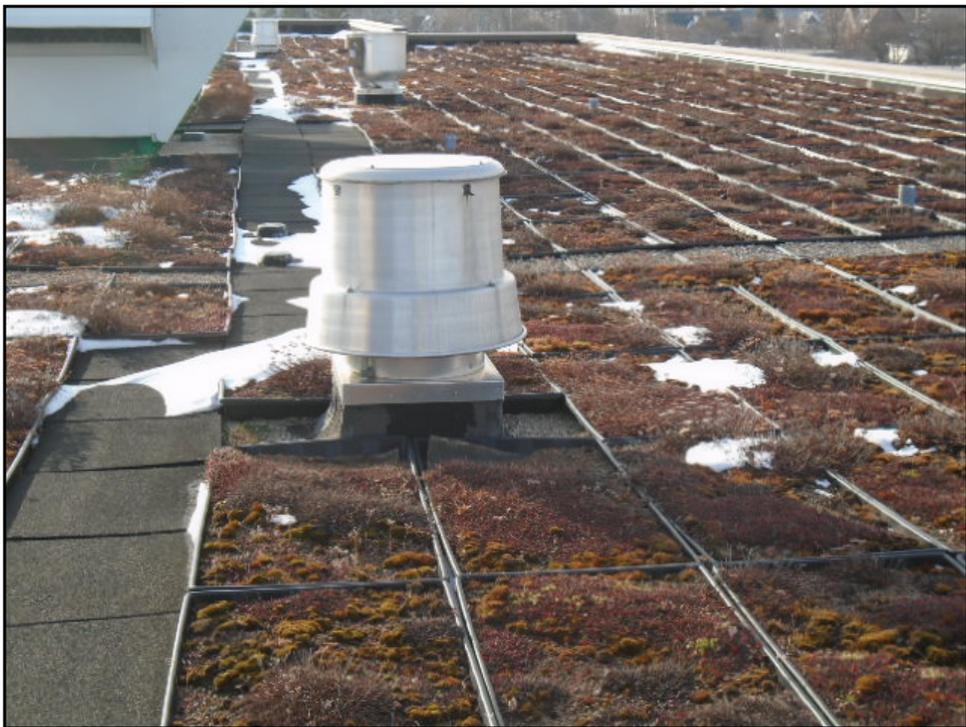
8 : Roofing Condition

Roofing at the property consists of flat/low slope built-up roof assemblies supported by reinforced concrete roof deck panels. The built-up roofing assemblies are surfaced with EPDM roofing membrane, presumed to be over rigid insulation and fiberboard. No roof leaks/issues were reported or observed. The EPDM roofing membrane was observed in fair physical condition; however, its replacement has bee included within the Immediate Repairs. Roof drainage is provided via internal roof drains located in select low lying areas. Roof drainage appeared adequate, is in good physical condition, and no ponding of water was observed.

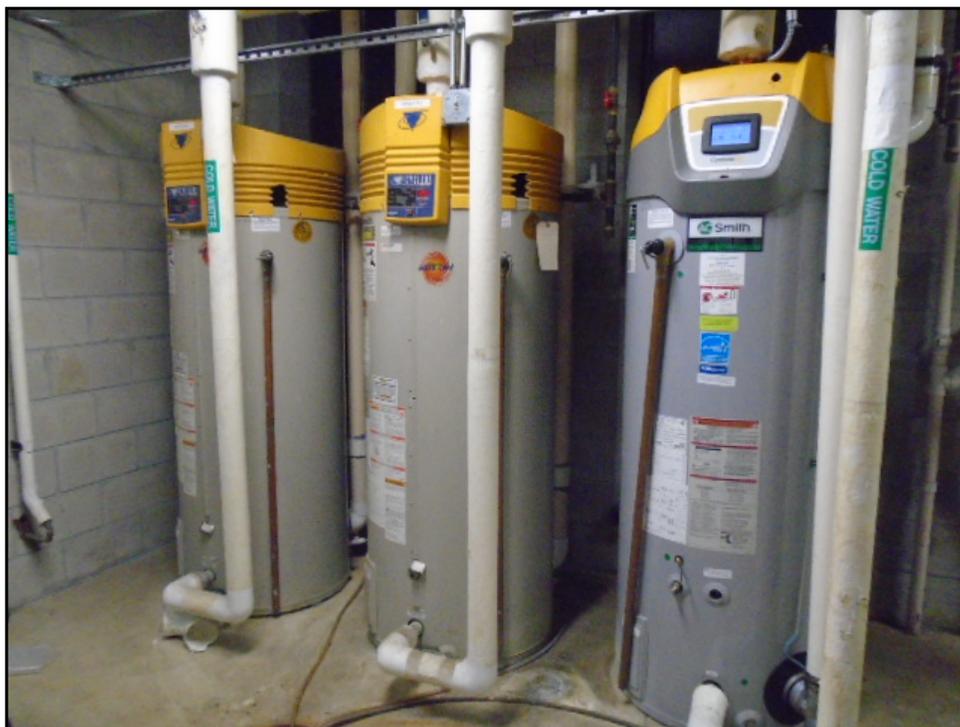
10 : Building Gas-Fired Central Domestic Hot Water Equipment

Dwelling units at the apartment buildings are provided domestic hot water via three (3) centrally located gas-fired boilers. The recovery of the hot water system is reported to be sufficient for the number of fixtures served and no complaints concerning a lack of hot water were raised during the inspection; however, the boilers are nearing the end of their EUL and their replacement has been included within the Immediate Repairs.

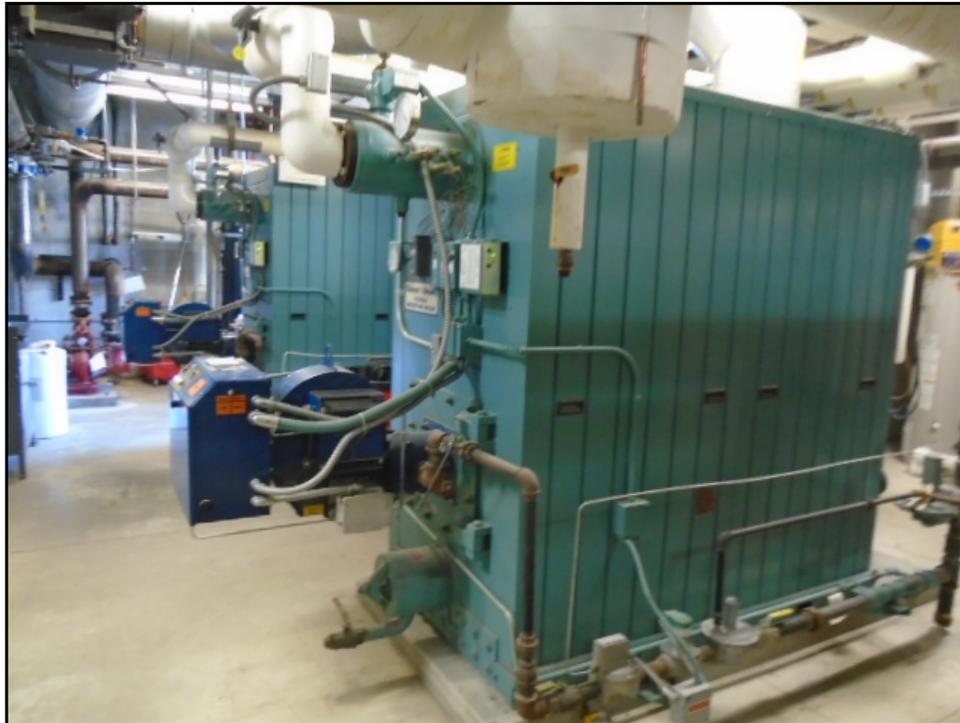
11 : Building Gas-Fired Central Heating Boilers

The dwelling units and common areas are provided heating via gas fired boilers which supply hot water to fan coil units and air handlers throughout the conditioned areas. The boilers were observed to be nearing the end of their EUL, and their replacement with new ENERGYSTAR rated HVAC equipment is required in order to comply with WHEDA QAP Appendix M (Immediate Repair).

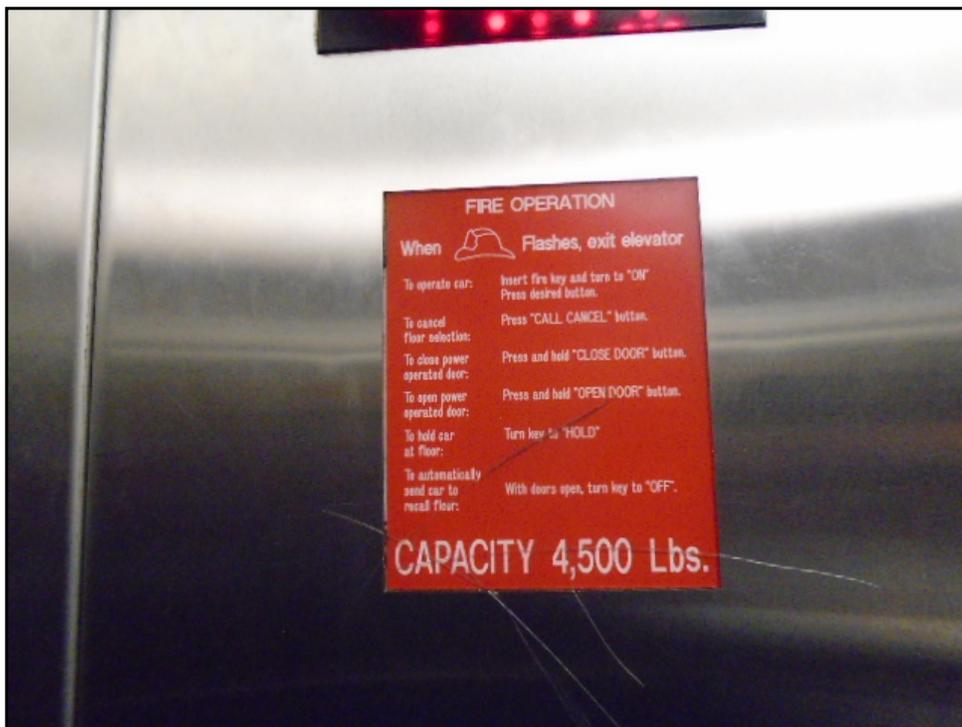
14 : Elevator Cab Interior

The building features two (2) 4,500-lb hydraulic elevators within CMU wall shafts. The elevators feature ADA and firemen's controls. The elevator interior cabs and equipment were observed in fair physical condition; however, are nearing the end of their EUL and the refurbishment of the interior cabs, mechanical and electrical systems has been included within the Immediate Repairs.

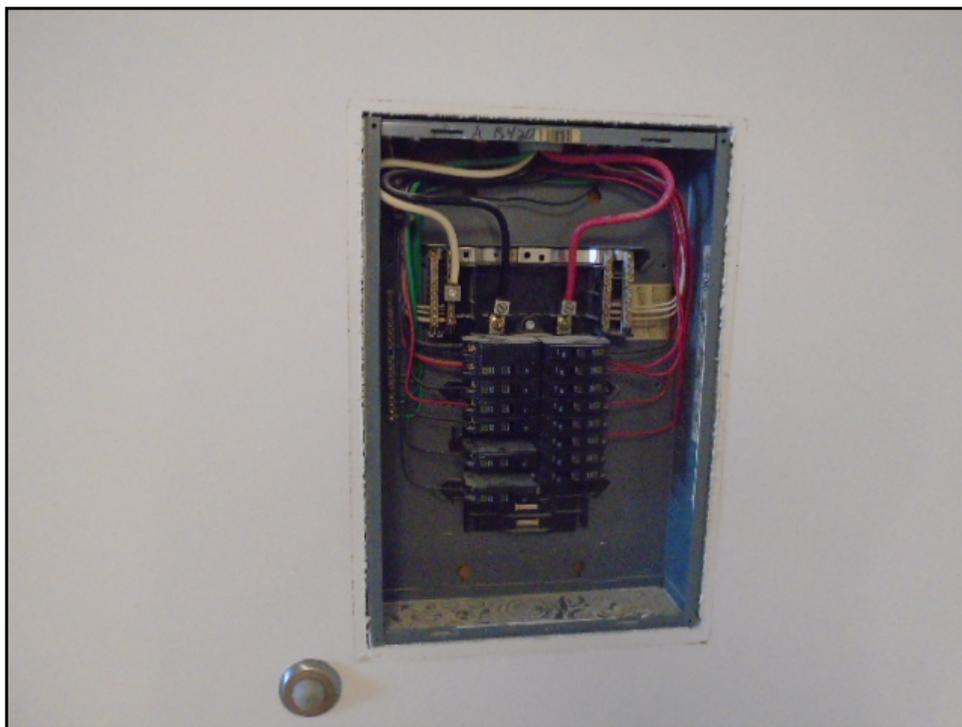
24 : Dwelling Unit Square D Electric Breaker Panel

The property receives electrical power from pad-mounted transformers. The dwelling units were observed with Square D electrical breaker panels located in the hall (120/240V, 100 Amps provided). The panels are original to the property (2004) and there are no reports of any service issues with the panels or electrical service. The panels were observed in good operating condition.

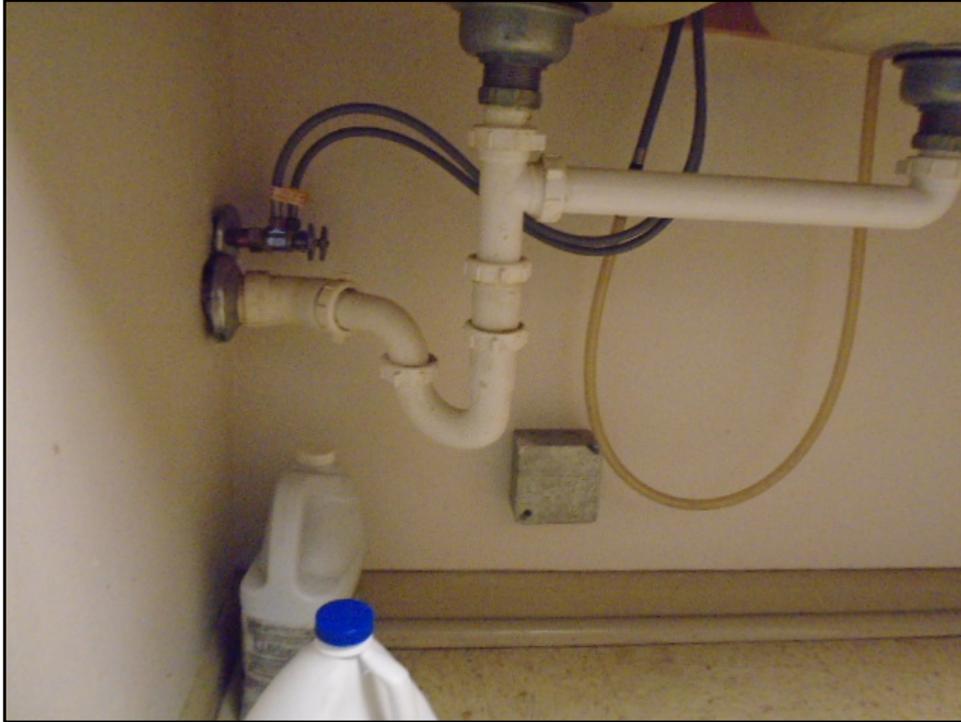
- The U-shaped kitchens do not feature compliant clear floor space due to encroachment by the refrigerators (Immediate Repair).
- Kitchen sinks in all of the accessible units were observed to be without scald and abrasion protection (Immediate Repair).
- Bathroom sink in unit 102 was observed to be without scald and abrasion protection (Immediate Repair).

33 : Non-Compliant Handicapped Dwelling Unit Kitchen Roll-Under Sink Missing Scald and Abrasion Protection (Immediate Repair)

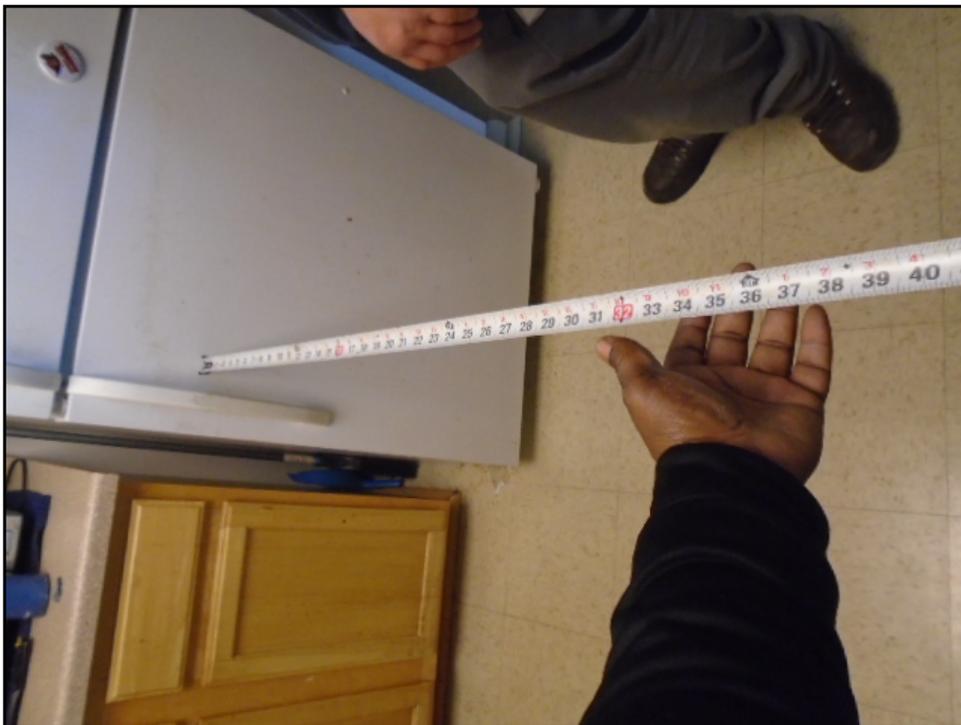
34 : View of an Example of Non-Compliant Kitchen Clear Floor Space Within the FHA and UFAS Dwelling Units Due to Encroachment By the Refrigerators 1 (Immediate Repairs)

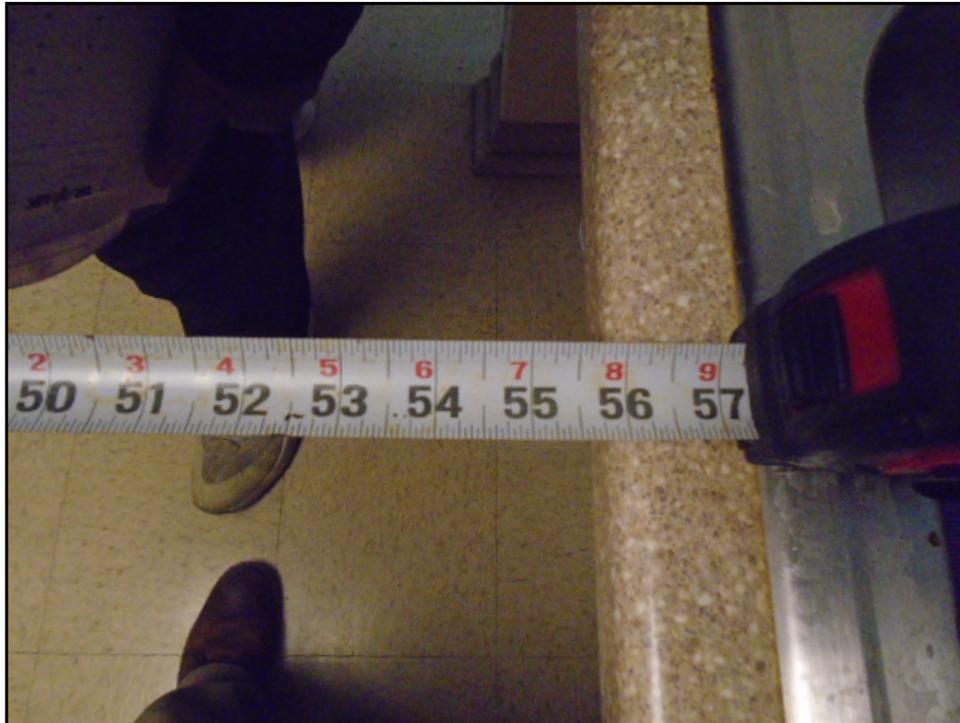
35 : View of an Example of Non-Compliant Kitchen Clear Floor Space Within the FHA and UFAS Dwelling Units Due to Encroachment By the Refrigerators 2 (Immediate Repairs)

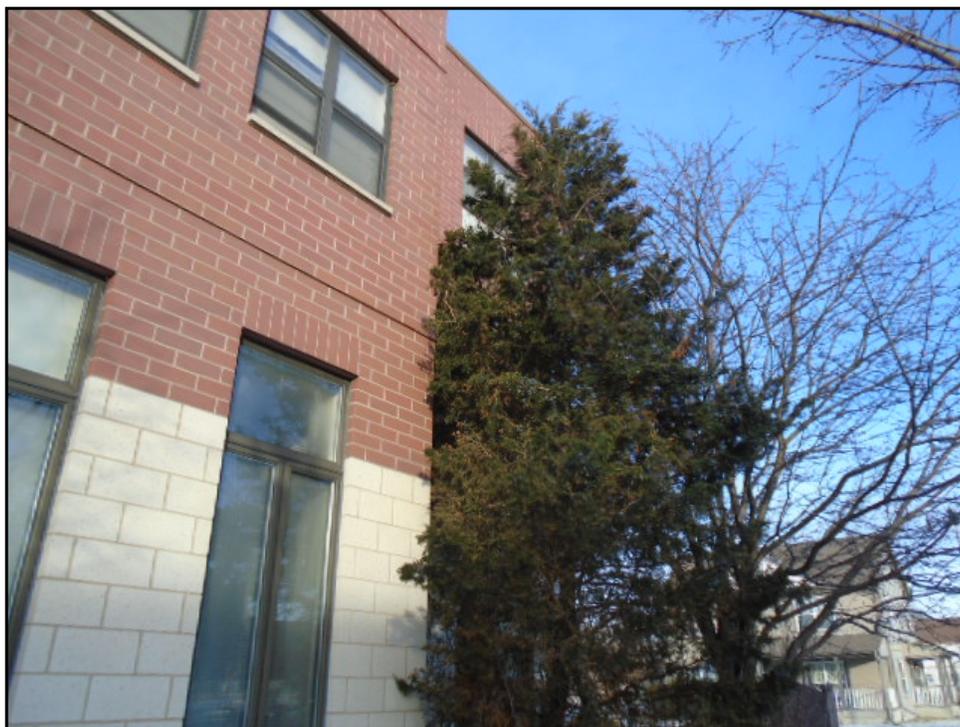
Landscaping consists of trees, shrubs, and grasses situated throughout the site and surrounding the apartment building. The existing landscaping was observed in fair to good physical condition with select improvements noted within the Immediate Repairs. The site does not feature an irrigation system.

36 : Trim Trees from Touching the Building (Non-Critical Repair)

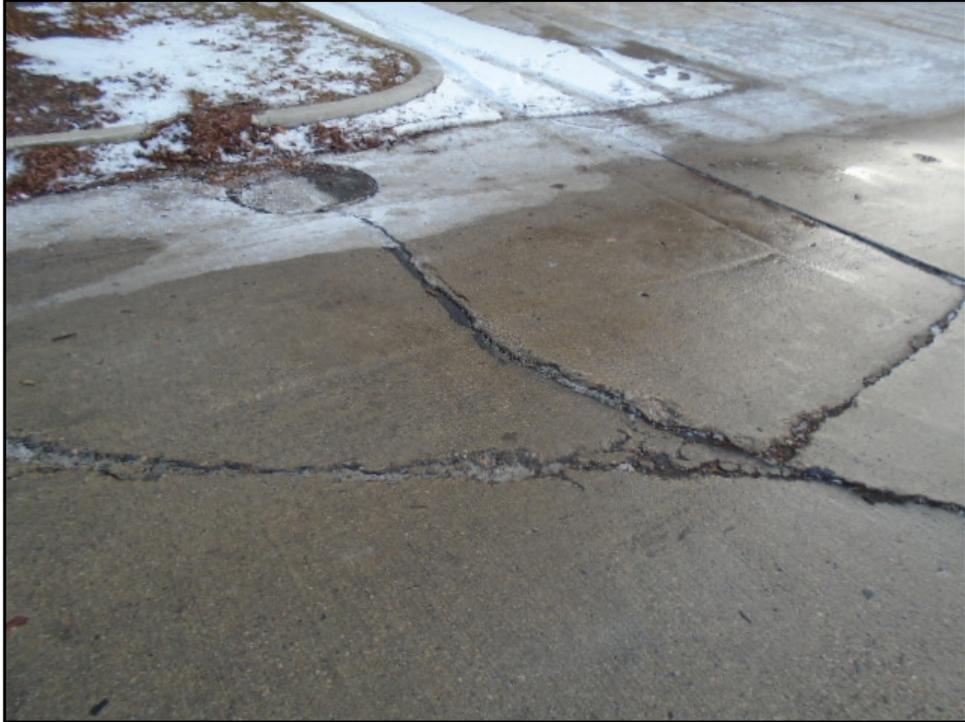
37 : Repair Damaged Concrete Parking Areas (Non-Critical Repair)
